An Example of River Training Works for Hydropower Production

Prof. Dr Jovan Despotović

University of Belgrade – Faculty of Civil Engineering
Department for Hydraulic & Environmental Engineering

Extended abstract

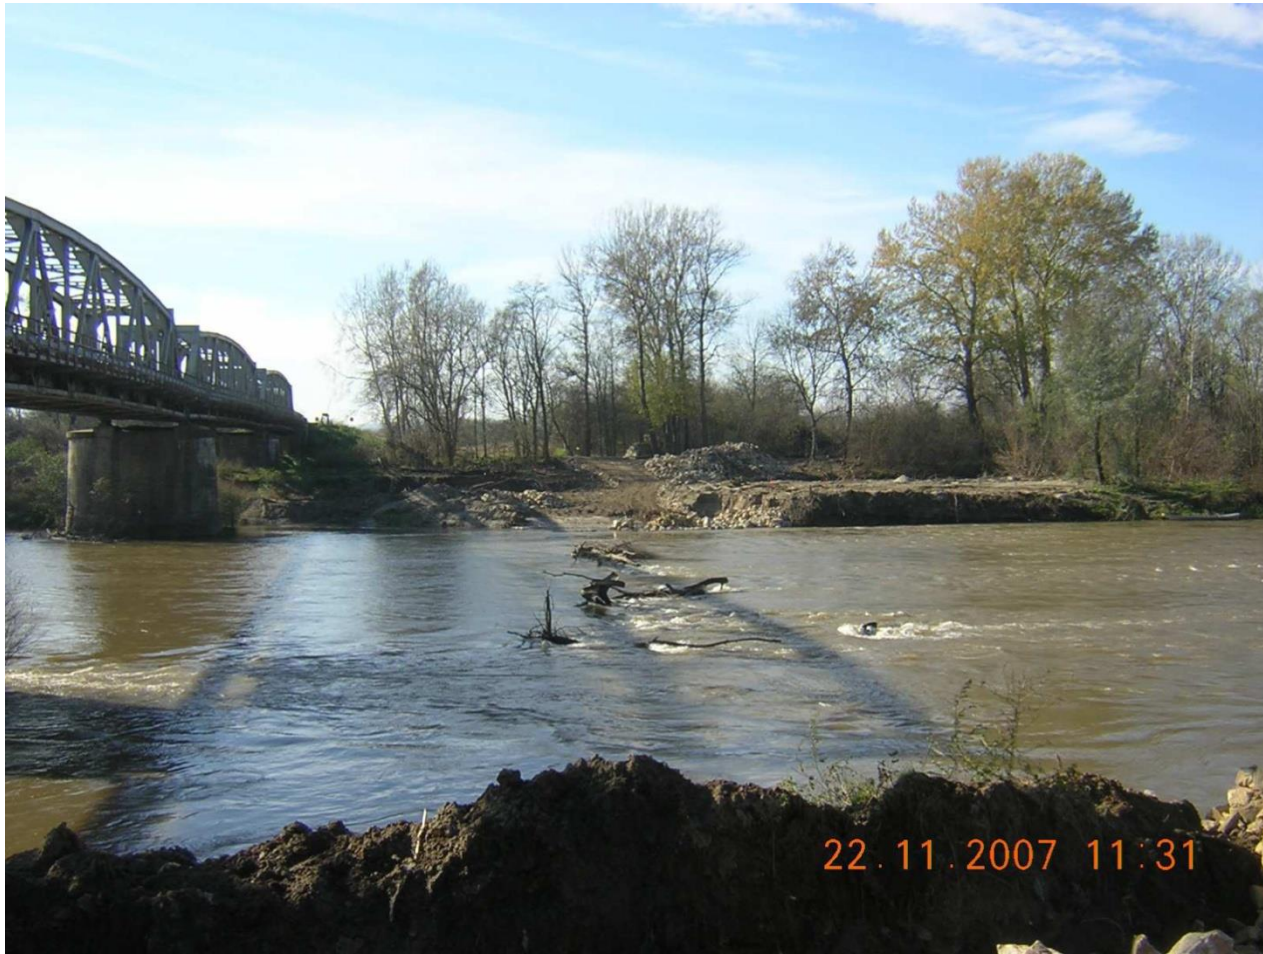
The river V. Morava profile incl. damaged steel bridge on the bottom from the 2nd World War that was used as the foundation for the sill with upstream gabion revetment.

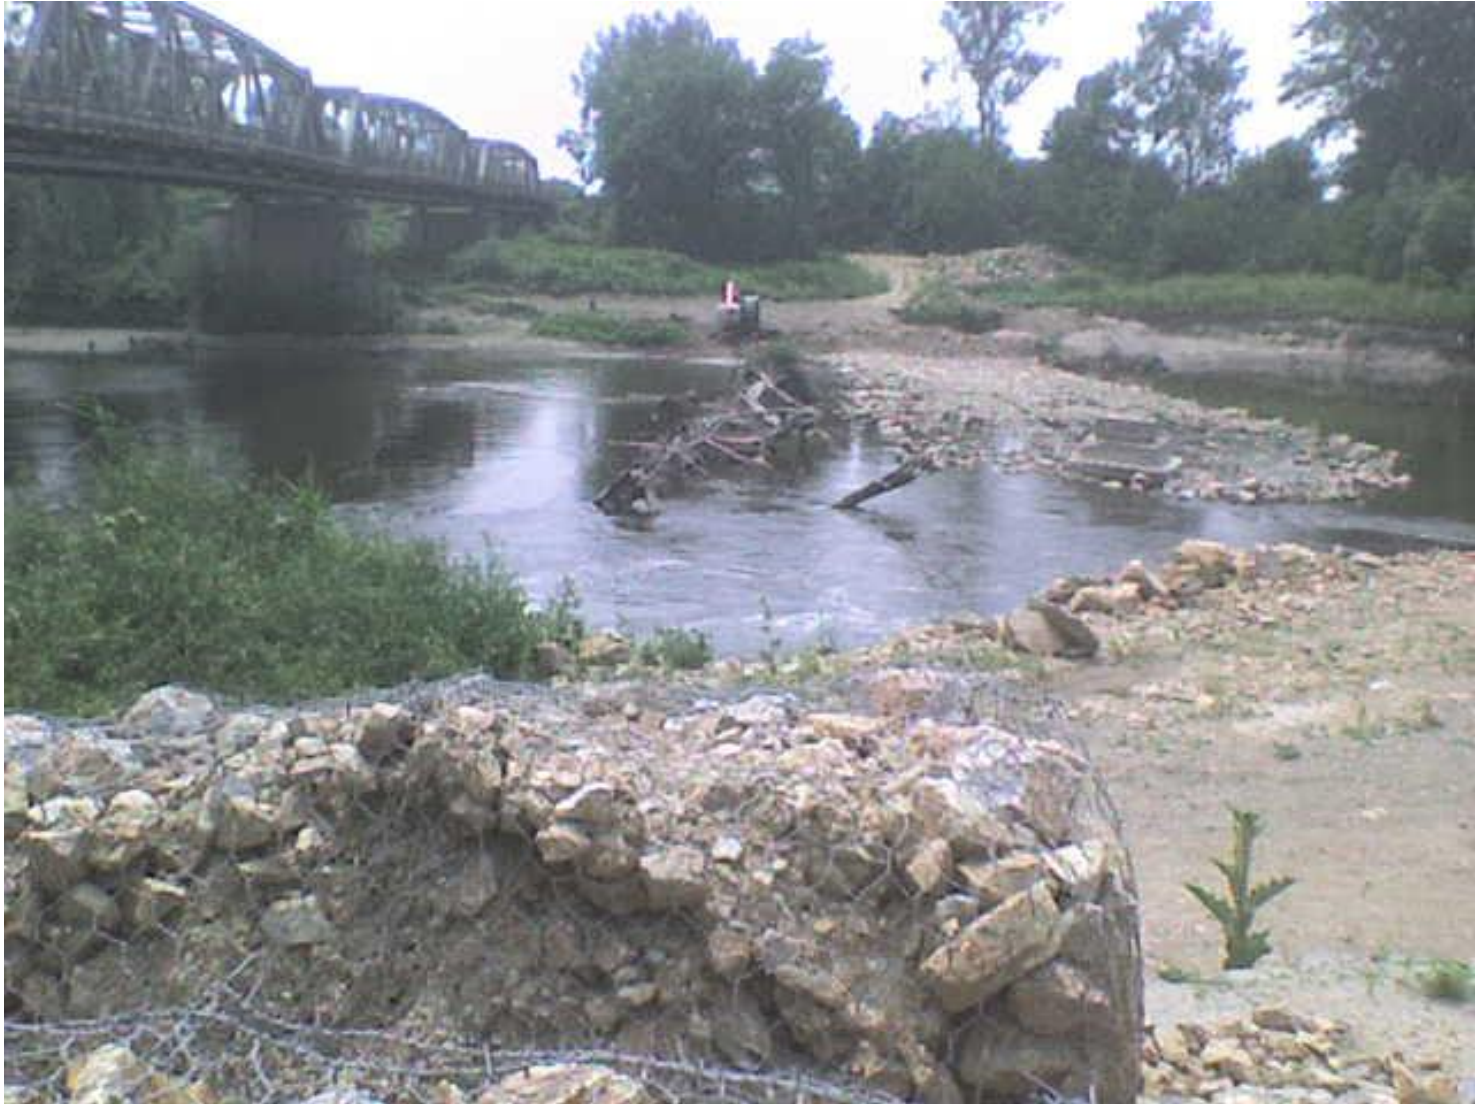
The designed sill under construction in allignment with the damaged old steel bridge at the bottom as the foundations.

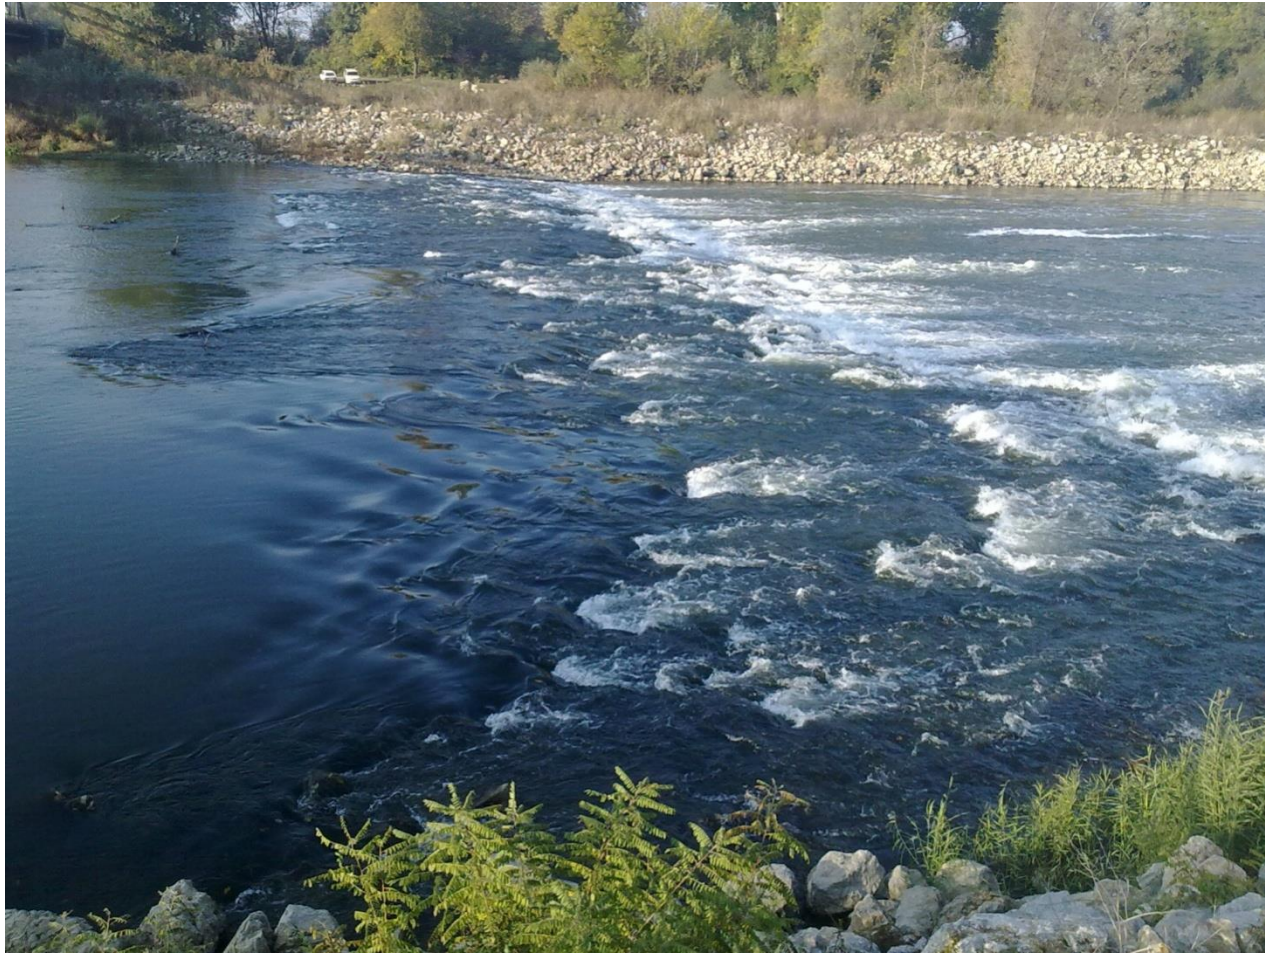
Overflow at sill which was noticeable but regular during first year after construction works at the end of year 2008.

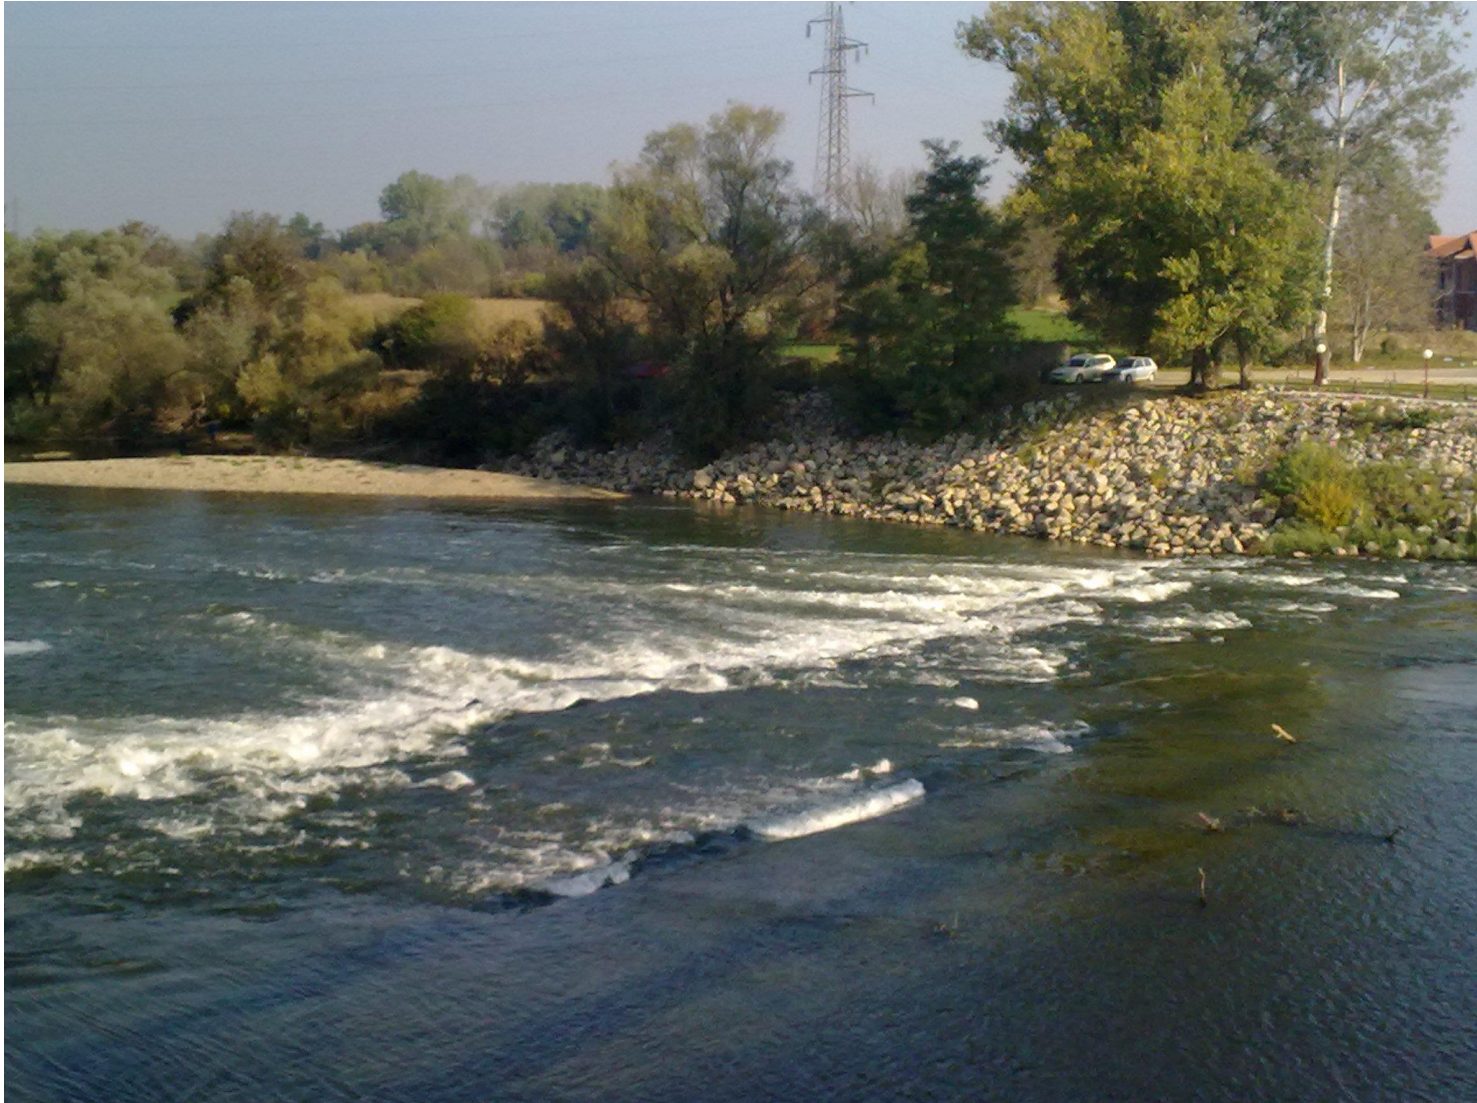
Overflow at sill which can be easily noticed during the low flows in the year 2011.

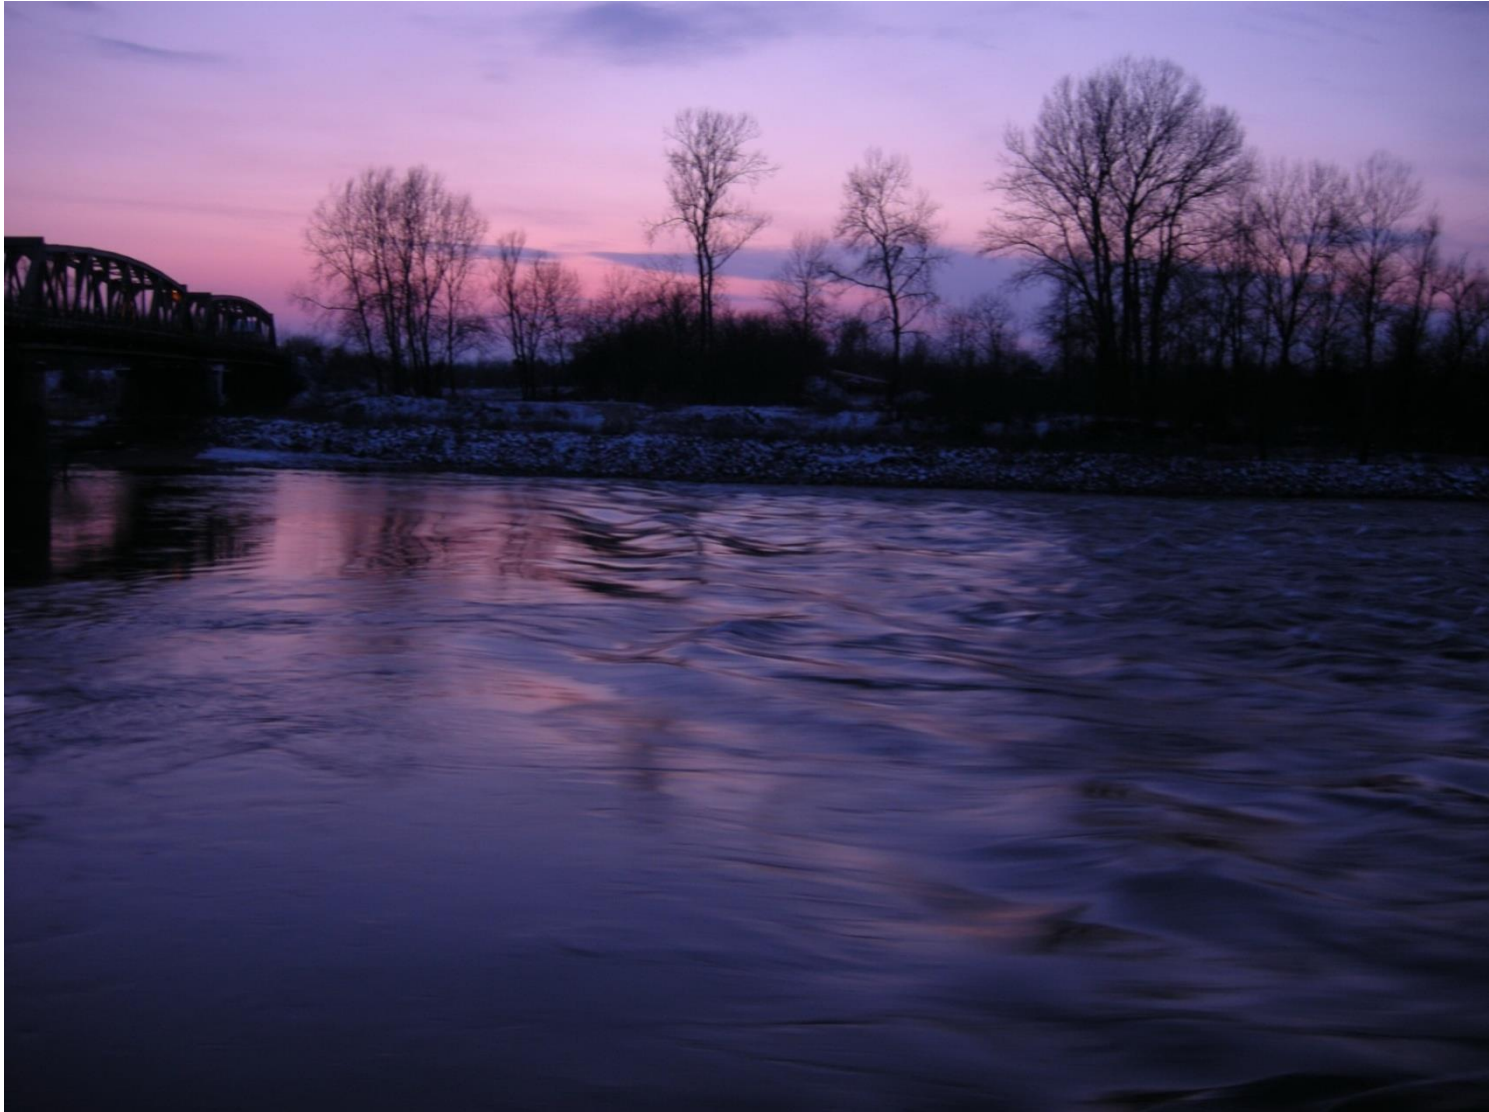
Overflow at sill, the effects of which couldn't be noticed, during high flows in the year 2010.

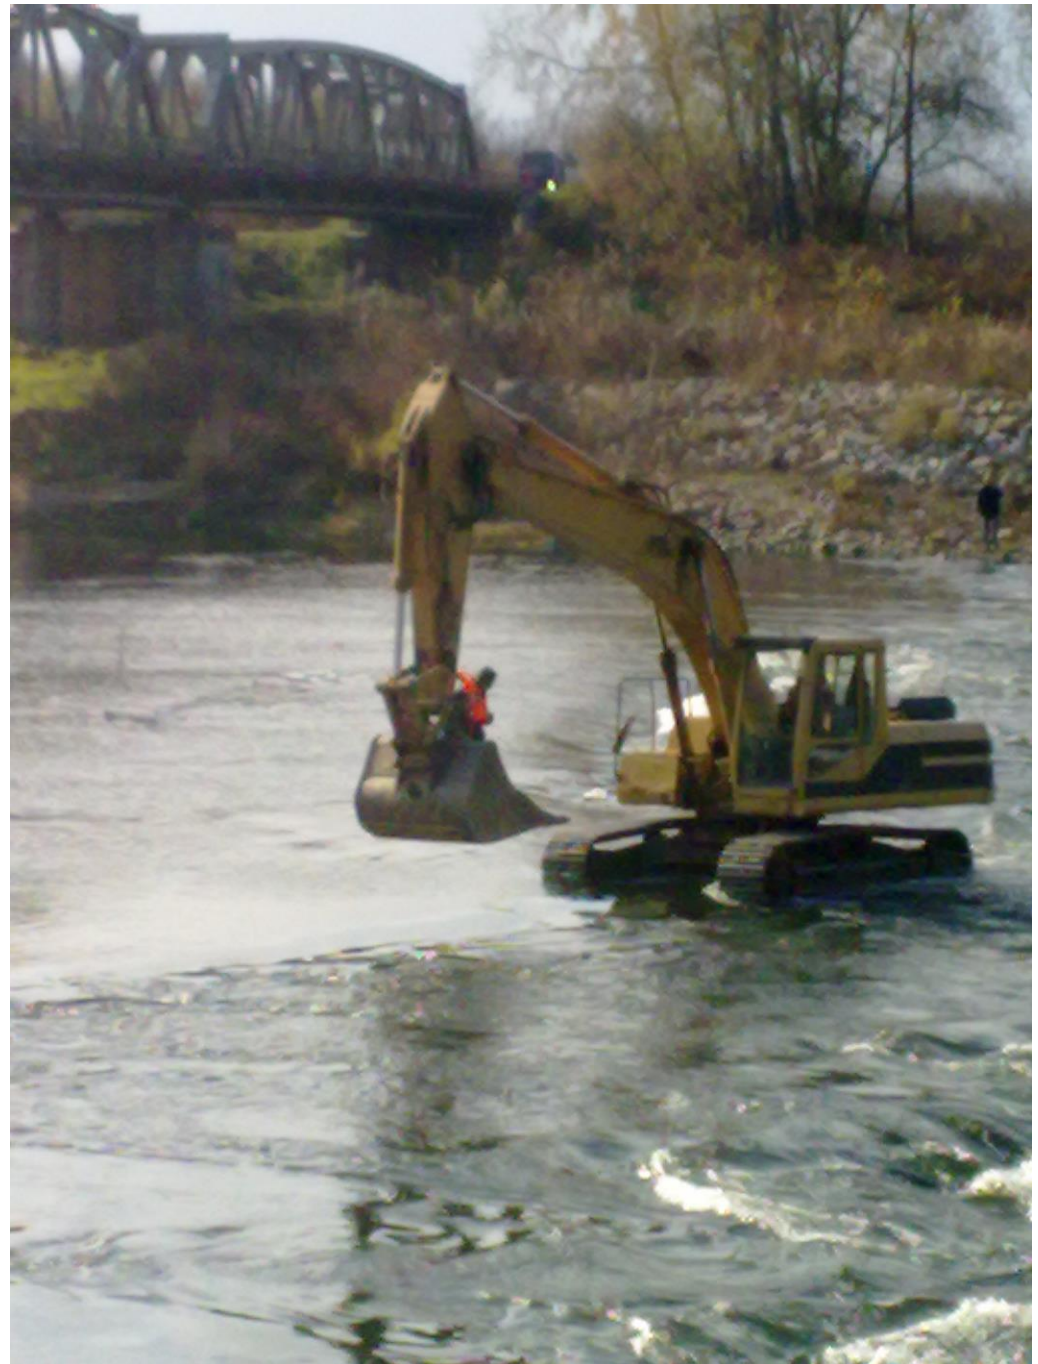
The comprehensive measurements of the sill dimensions and the river V. Morava bed deformations upstream and downstream the sill / holes, dunes, deposition/ after almost 4 years of the completion of the construction works in the year 2011.

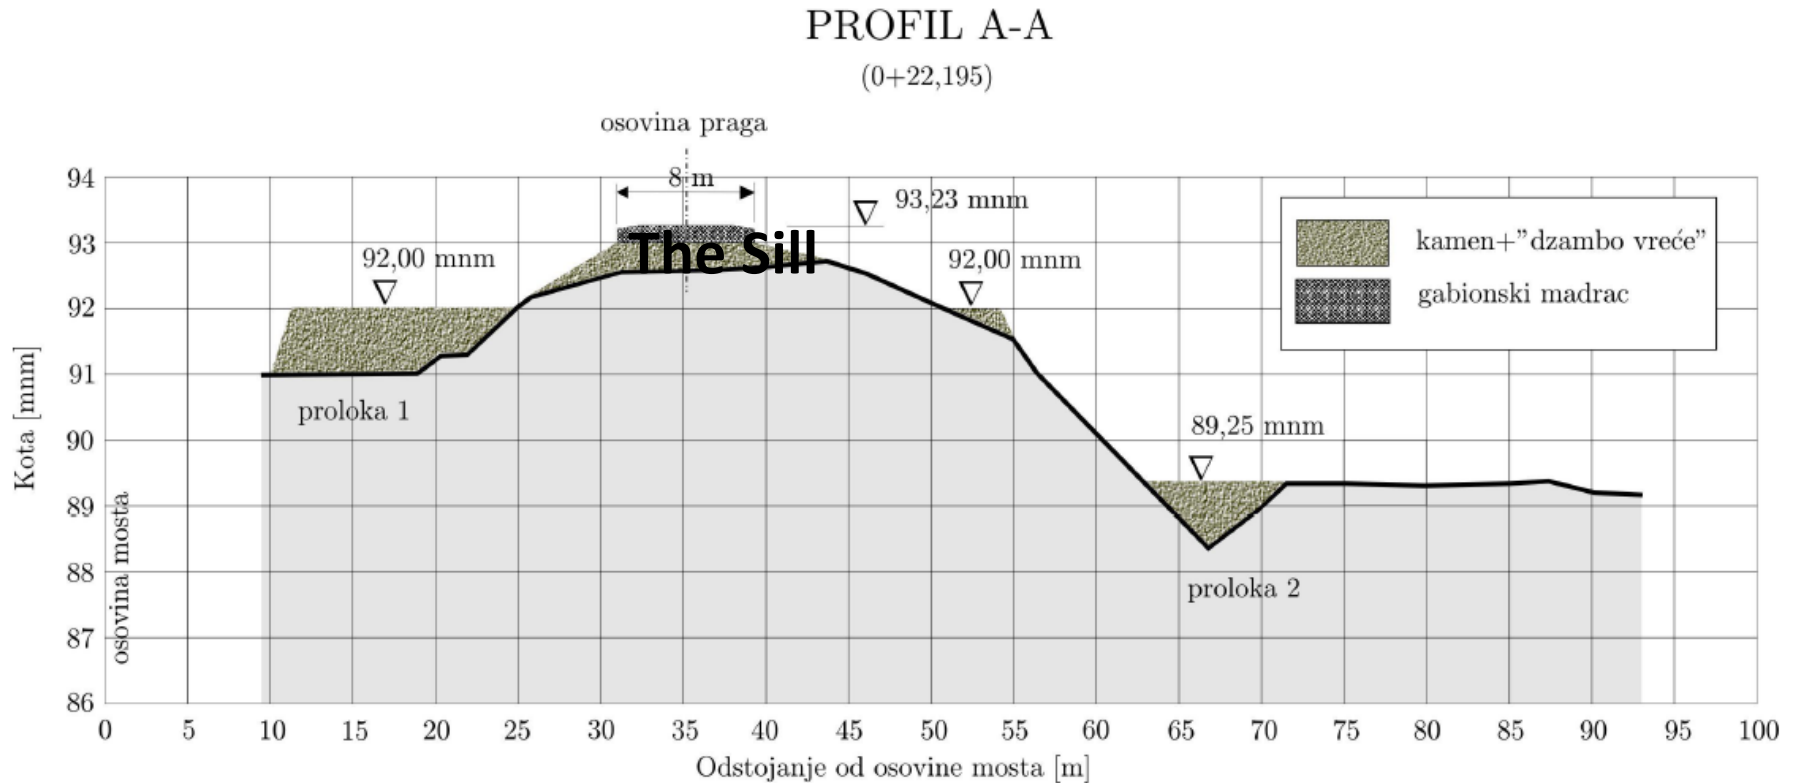
Monitoring of the sill has shown deformation of its body and the characteristics for stone structures after severe floods.

Systematic continuous maintenance that was emphasized is needed, for which adequate amount of money has to be provided on regular basis.

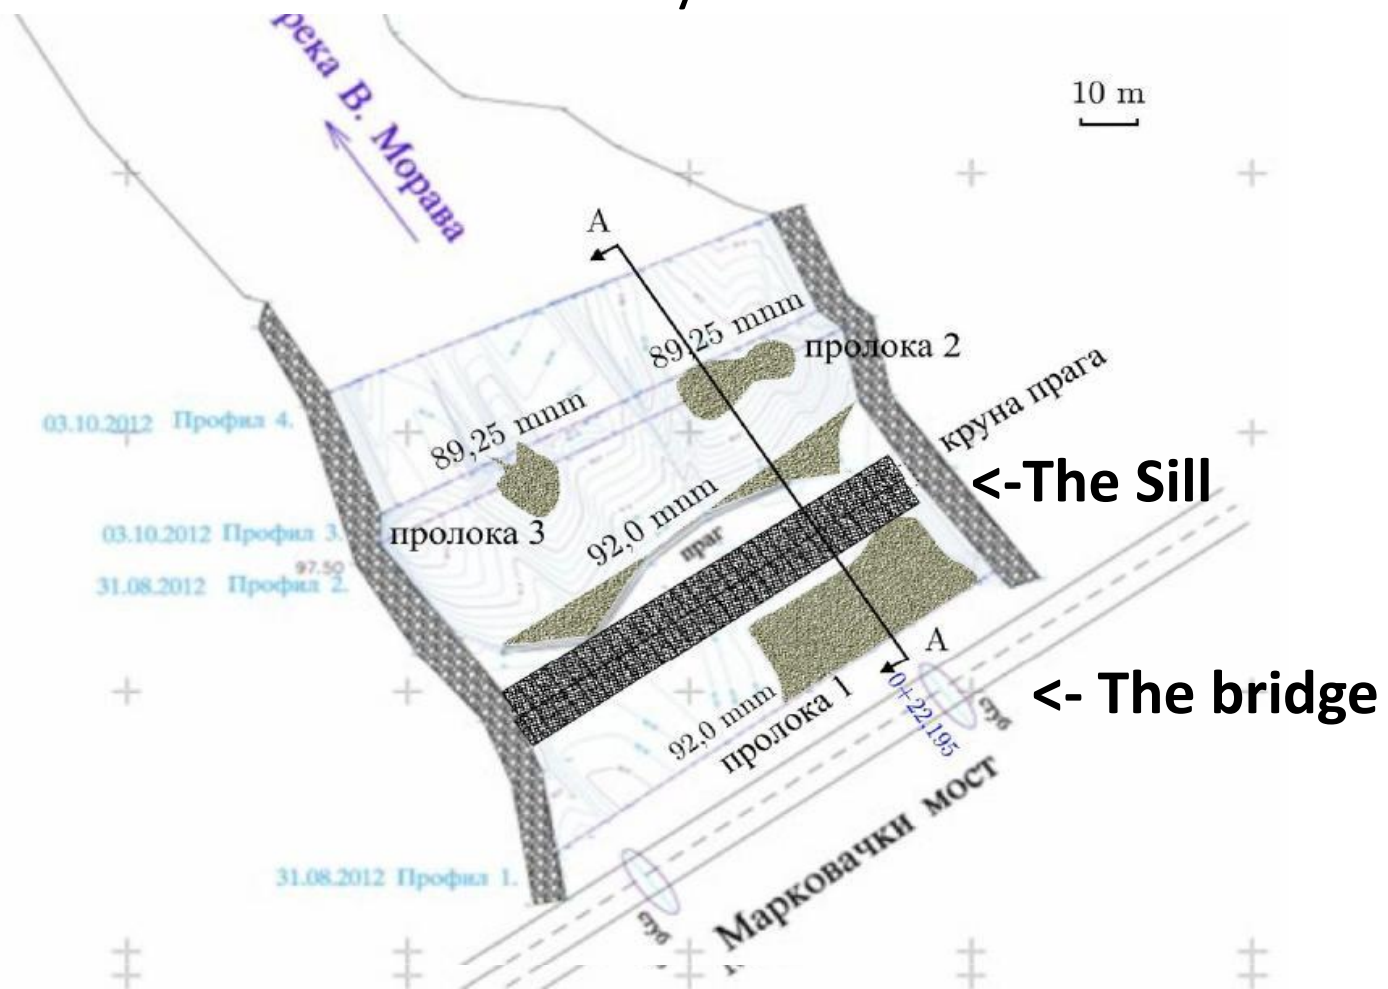
Monitoring of the sill including the both banks: severe deformation of its body and the characteristics of the stone structures (after several severe floods from year 2010, including 2014)
Systematic continuous maintenance is needed on a regular basis.
In year 2013 is done a design project for rehabilitation was done and in the year 2014 must be constructed!
