# Comparison of core sampling and visual inspection for assessment of sewer pipe condition

N. Stanić, C. de Haan, M. Tirion, J. Langeveld and F. Clemens

9<sup>th</sup> International Joint IWA/IAHR Conference on Urban Drainage Modelling 2012, Belgrade

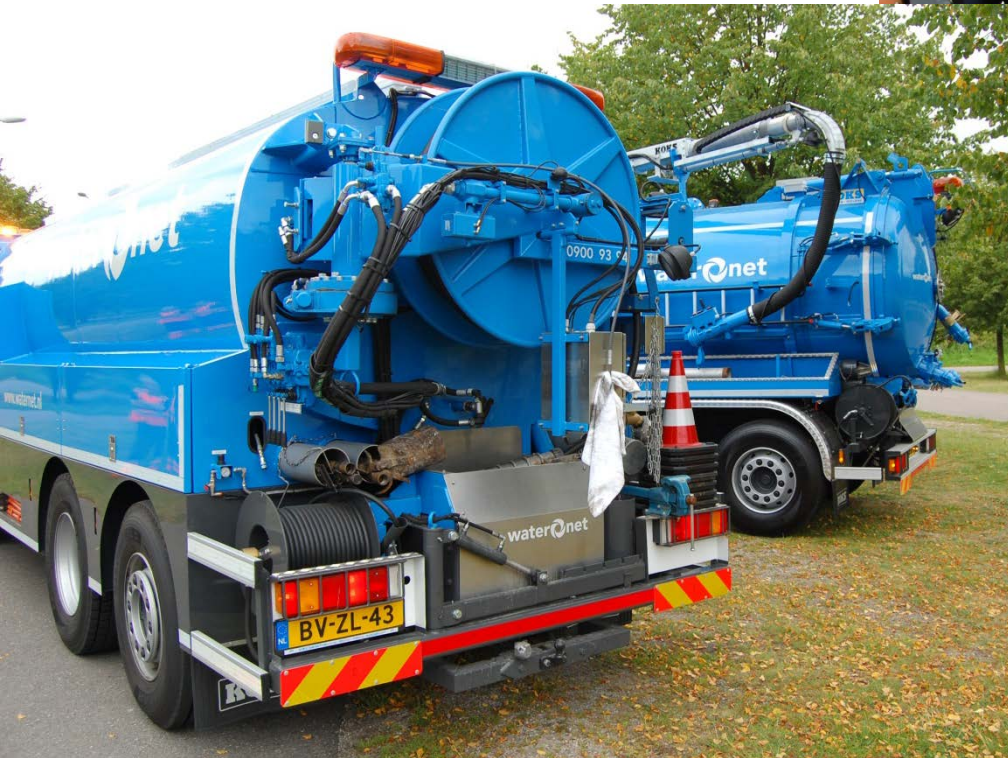
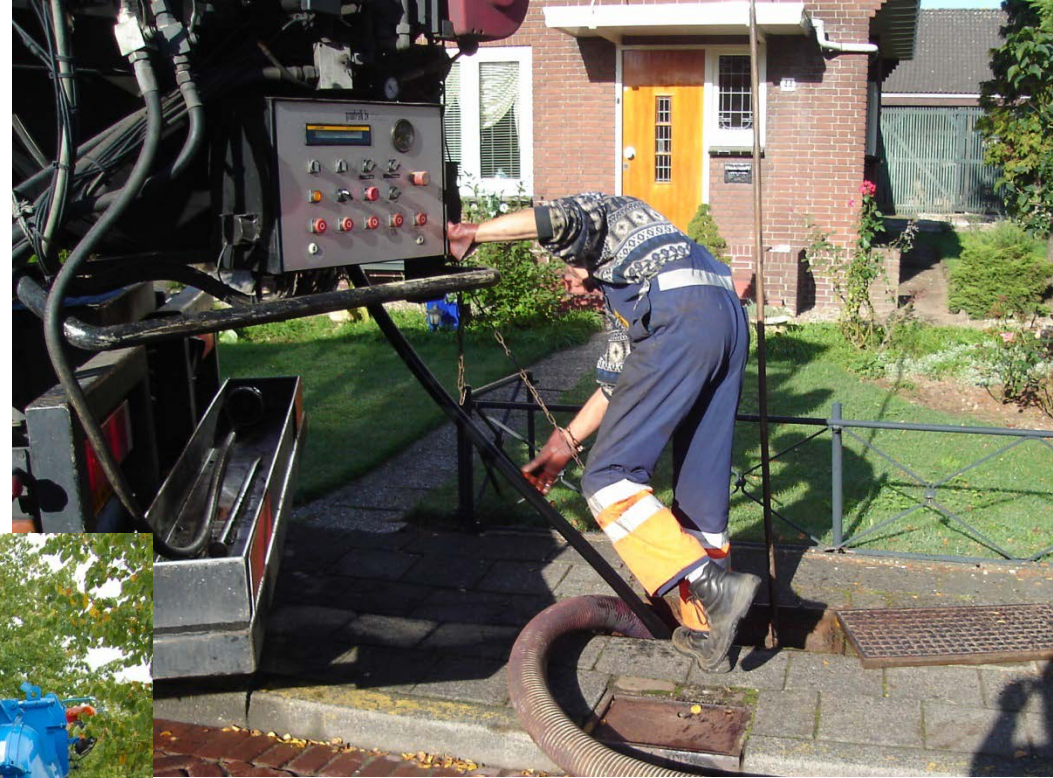
### 1. Cleaning

## Visual inspection - CCTV

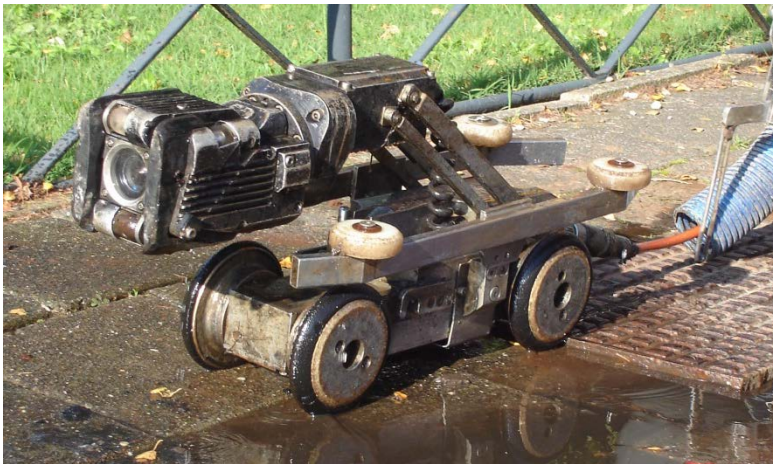
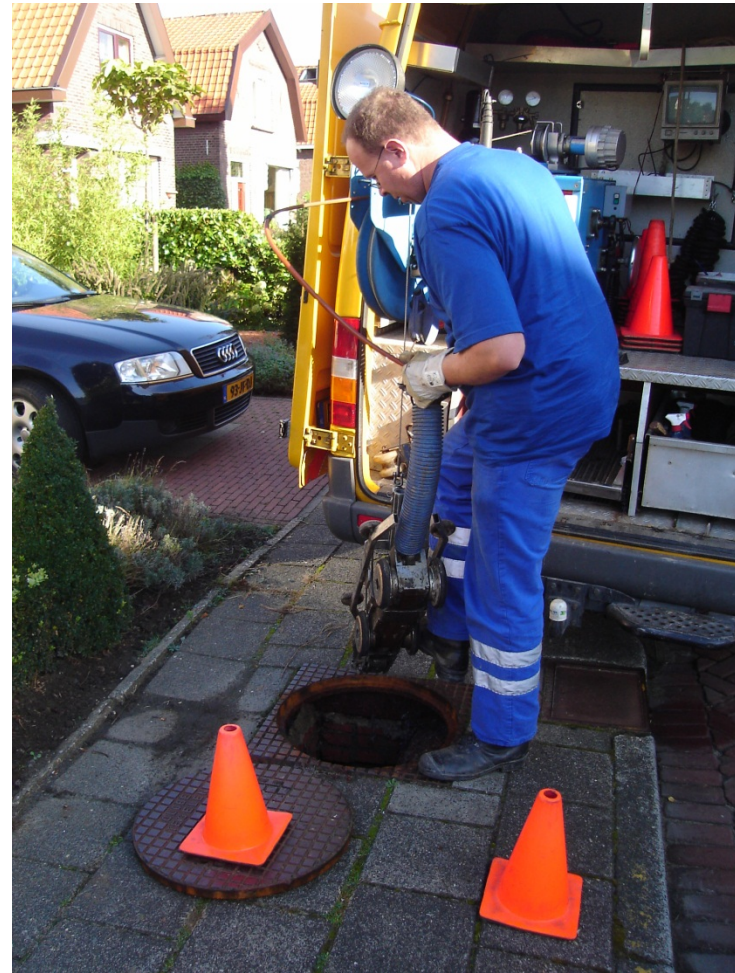
### 2. Installation of camera

## Visual inspection - CCTV

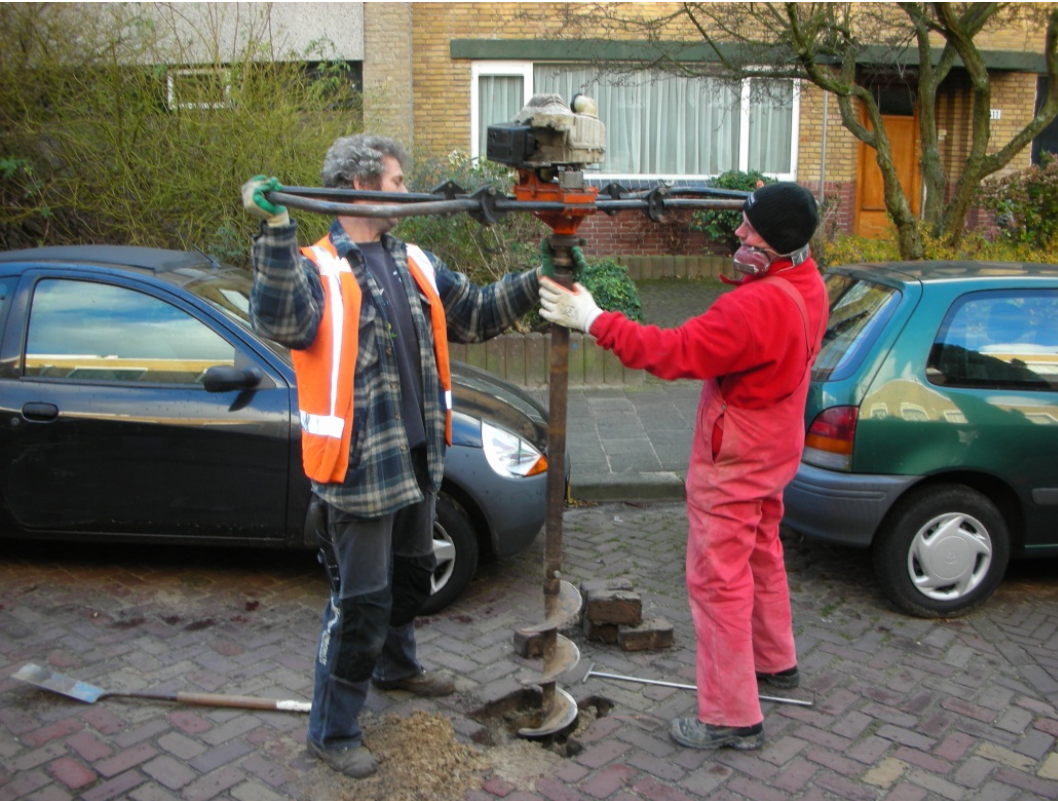
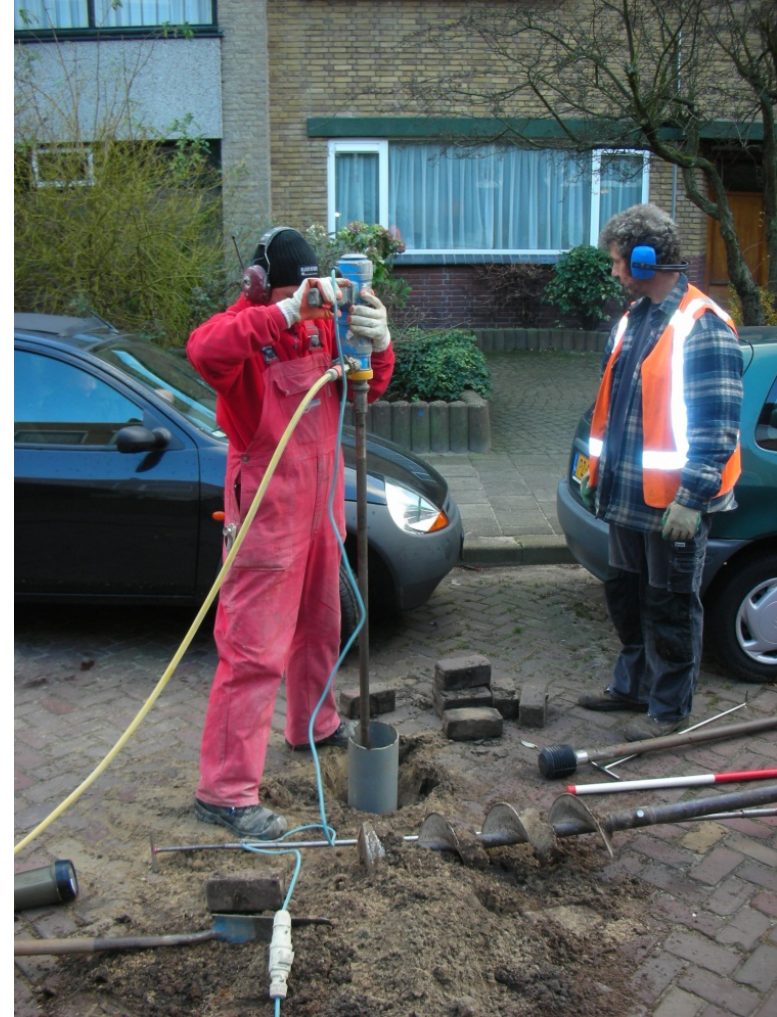
### 1. Drilling

## Drill core sampling

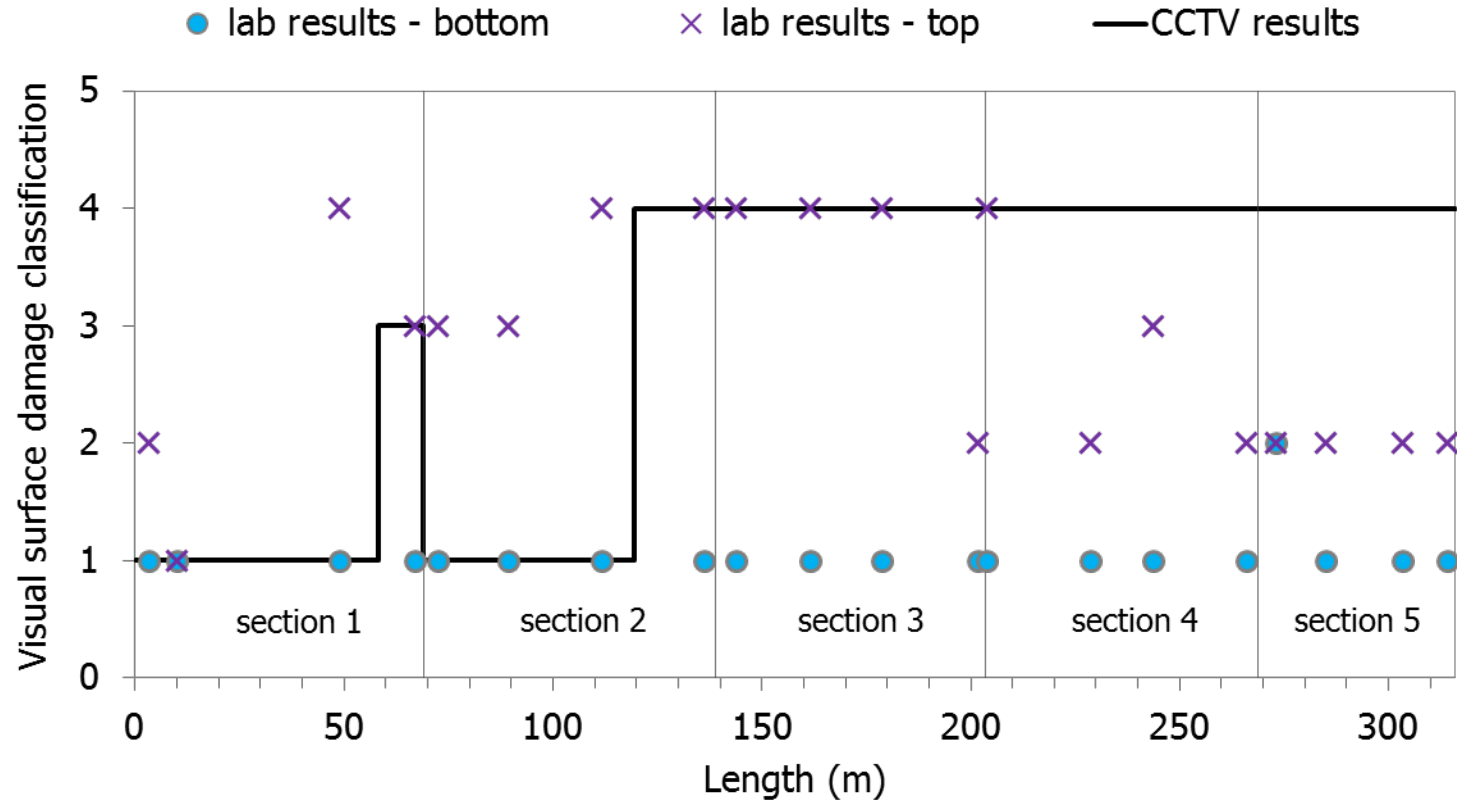
CCTV and lab. visual inspection results of the drill cores

- Laboratory visual assessment of core samples and CCTV visual assessment of sewer condition showed that classification can differ due to the different size of the observed surface area and subjective assessment.
- The quality of final core classification depends on selection of parameters and their classification.
- Different factors like non-uniform deterioration, height/diameter ratio, experimental uncertainty and damage during drilling influence the proper estimation of the splitting tensile strength which makes results unreliable.
- There is no obvious correlation between results of visual inspection and results of drill core analysis.

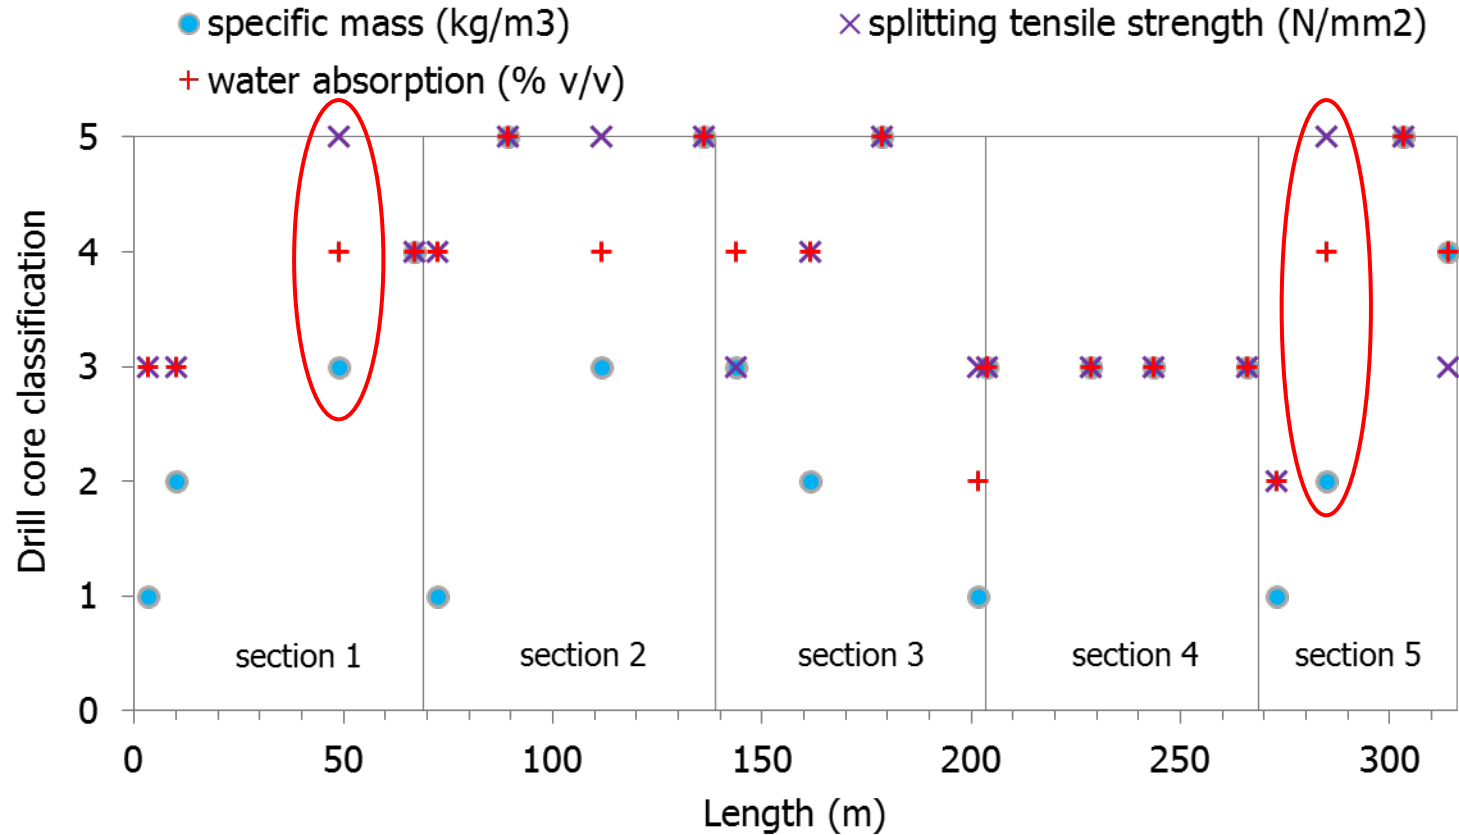
## Drill core classification from the top of the sewer

class 1	class 2	class 3	class 4	class 5
Splitting tensile strength (N/mm <sup>2</sup> )	>6	5-6	2.6-4.9	2.5-2	<2
Water absorption (%)	<8	8-9	9-11	11-13.5	>13.5
Specific weight (kg/m <sup>3</sup> )	>2275	2230-2275	2190-2229	2150-2189	<2150

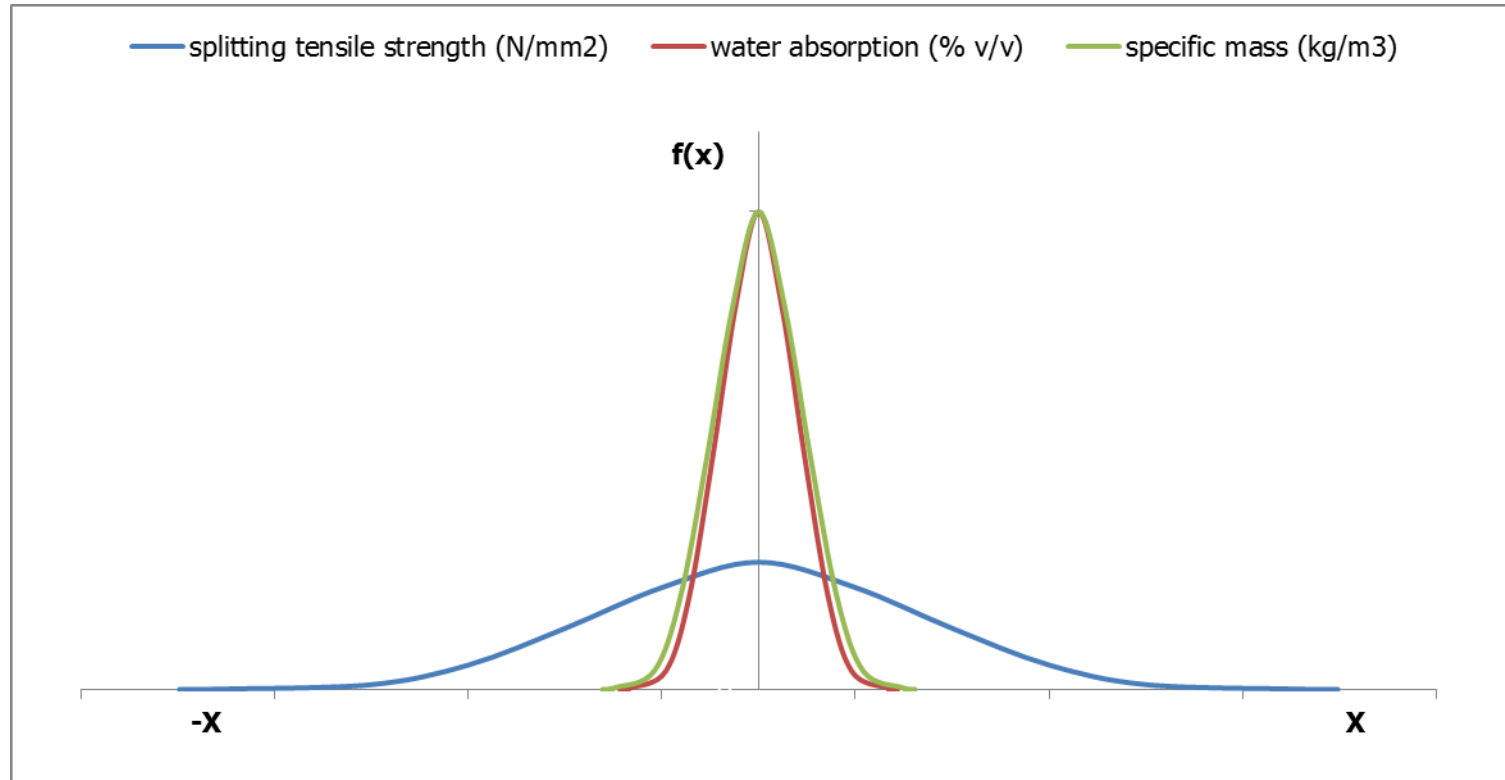
## Uncertainties of the three drill core criteria

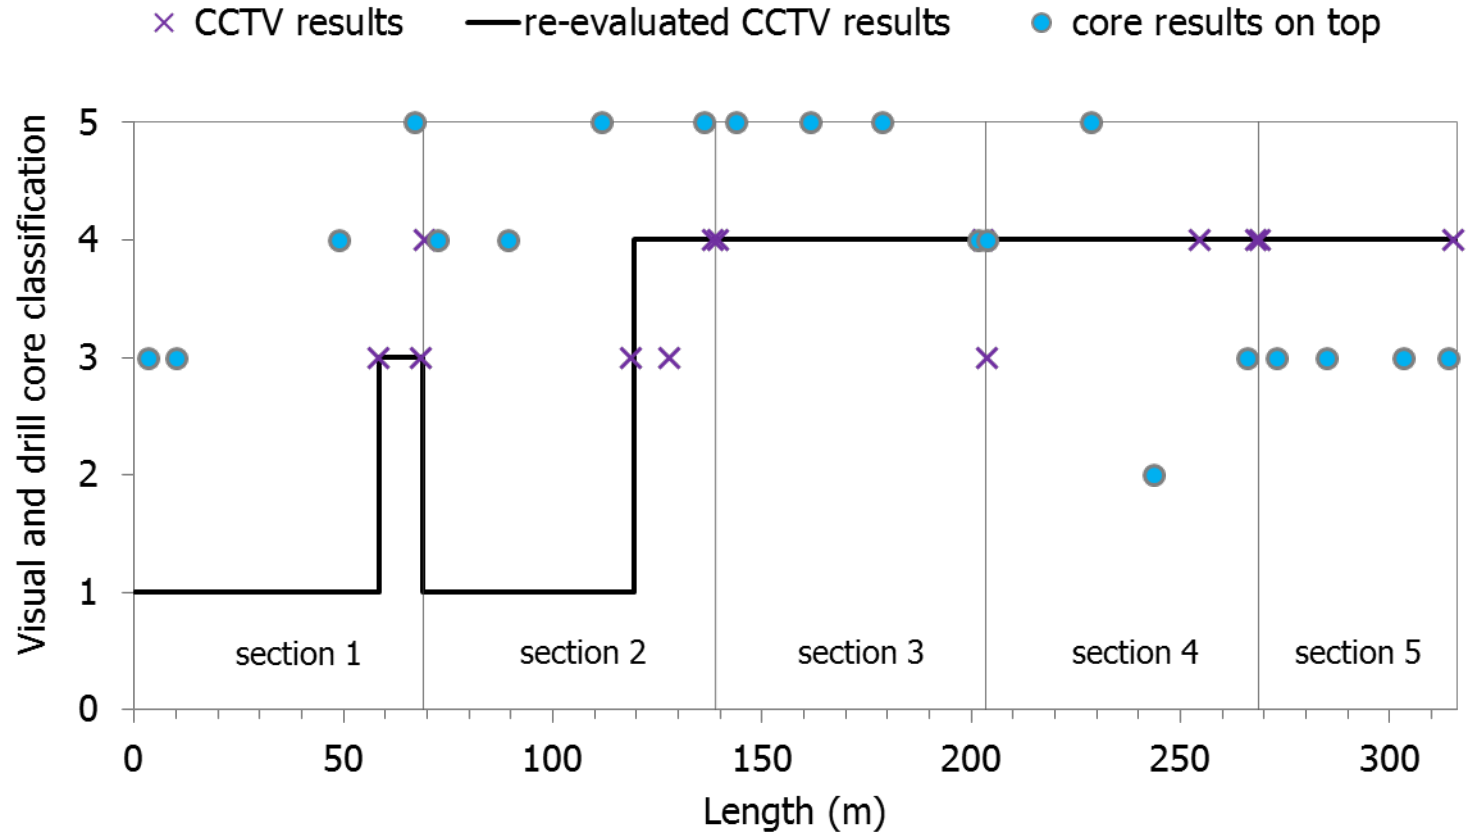
## Final conditions assessment

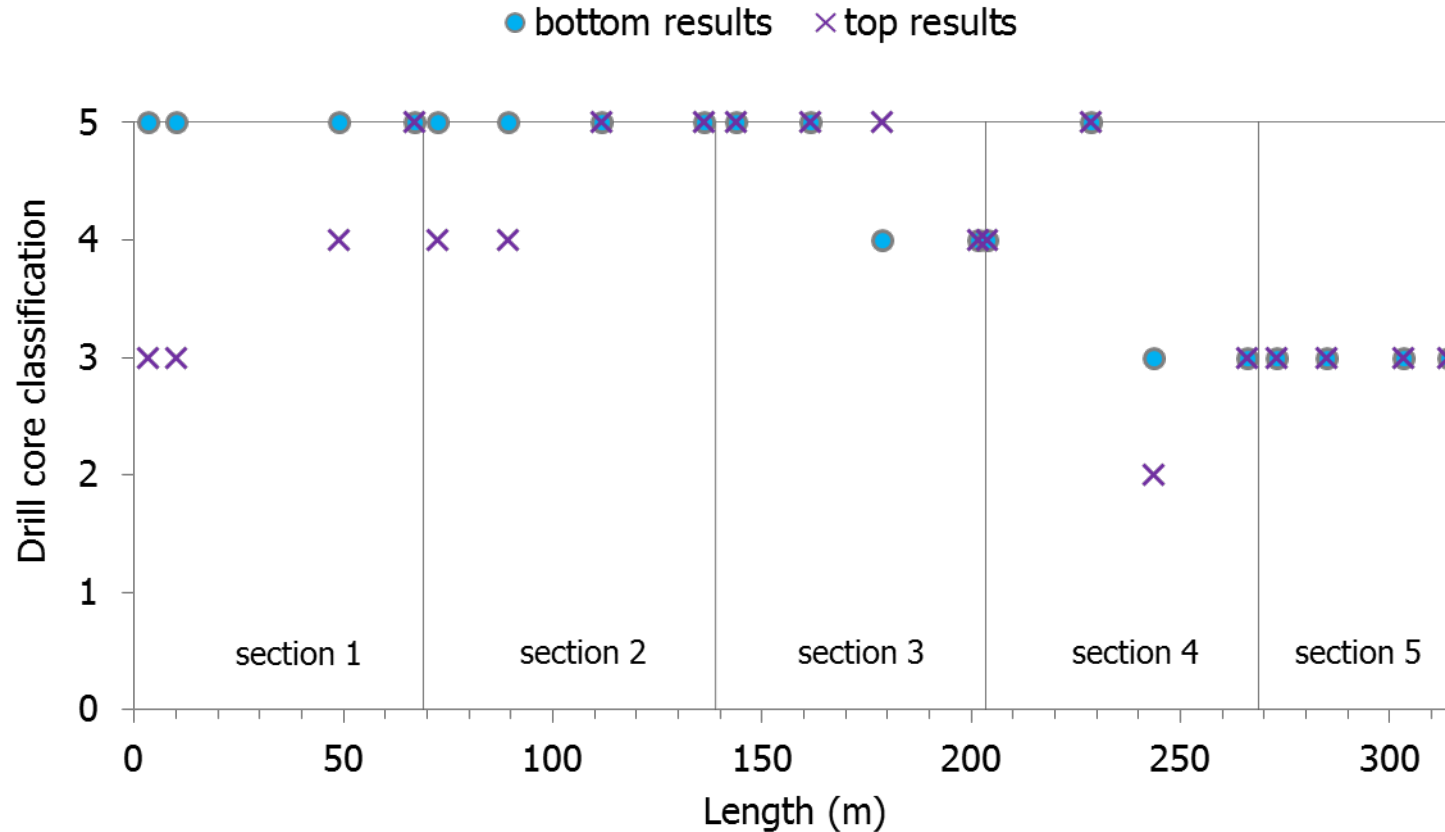
## Comparison of invert and top of the sewer drill cores
