*Impact of sewer condition on urban flooding:
a comparison between simulated and measured
system behaviour*

Marco van Bijnen/Hans Korving/François Clemens

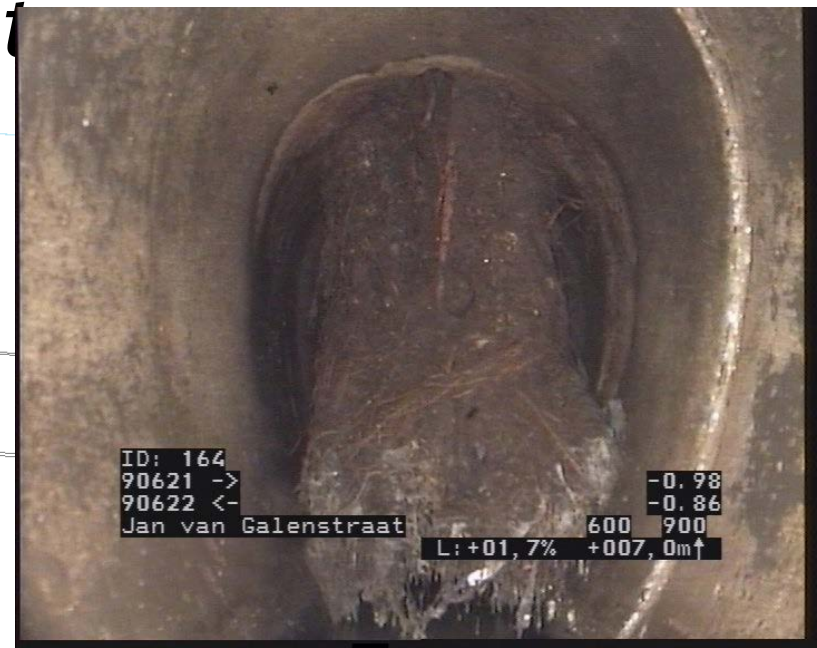
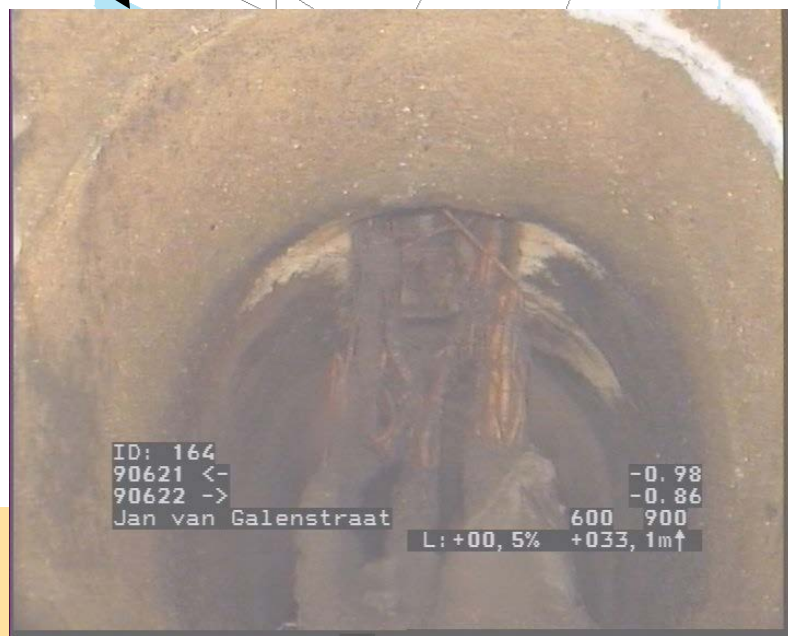
Root intrusion

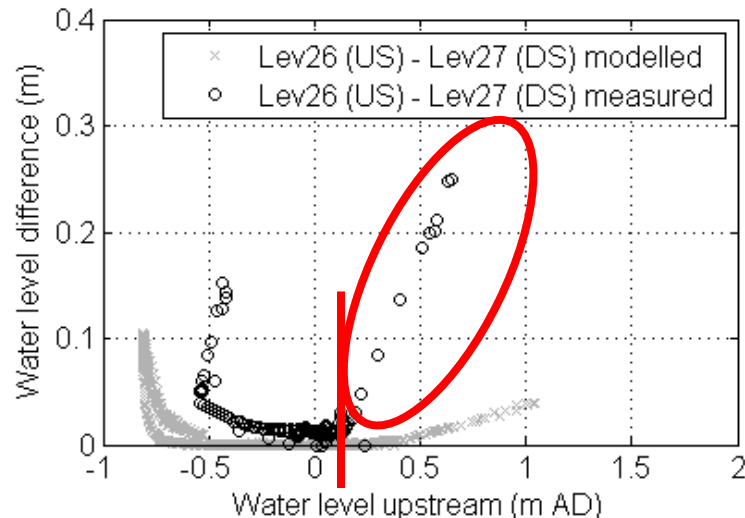
Jan van Galenstraat - Event 25/08/2010 - 28/08/2010

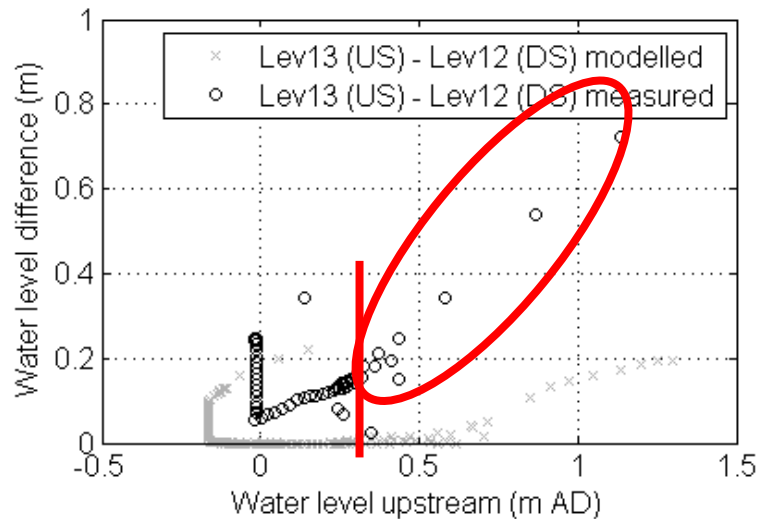
Prof. Jordanlaan - Event 10/07/2010 - 11/07/2010
