An Example of River Training Works for Hydropower Production

Prof. Dr Jovan Despotović

University of Belgrade – Faculty of Civil Engineering
Department for Hydraulic & Environmental Engineering

Extended abstract

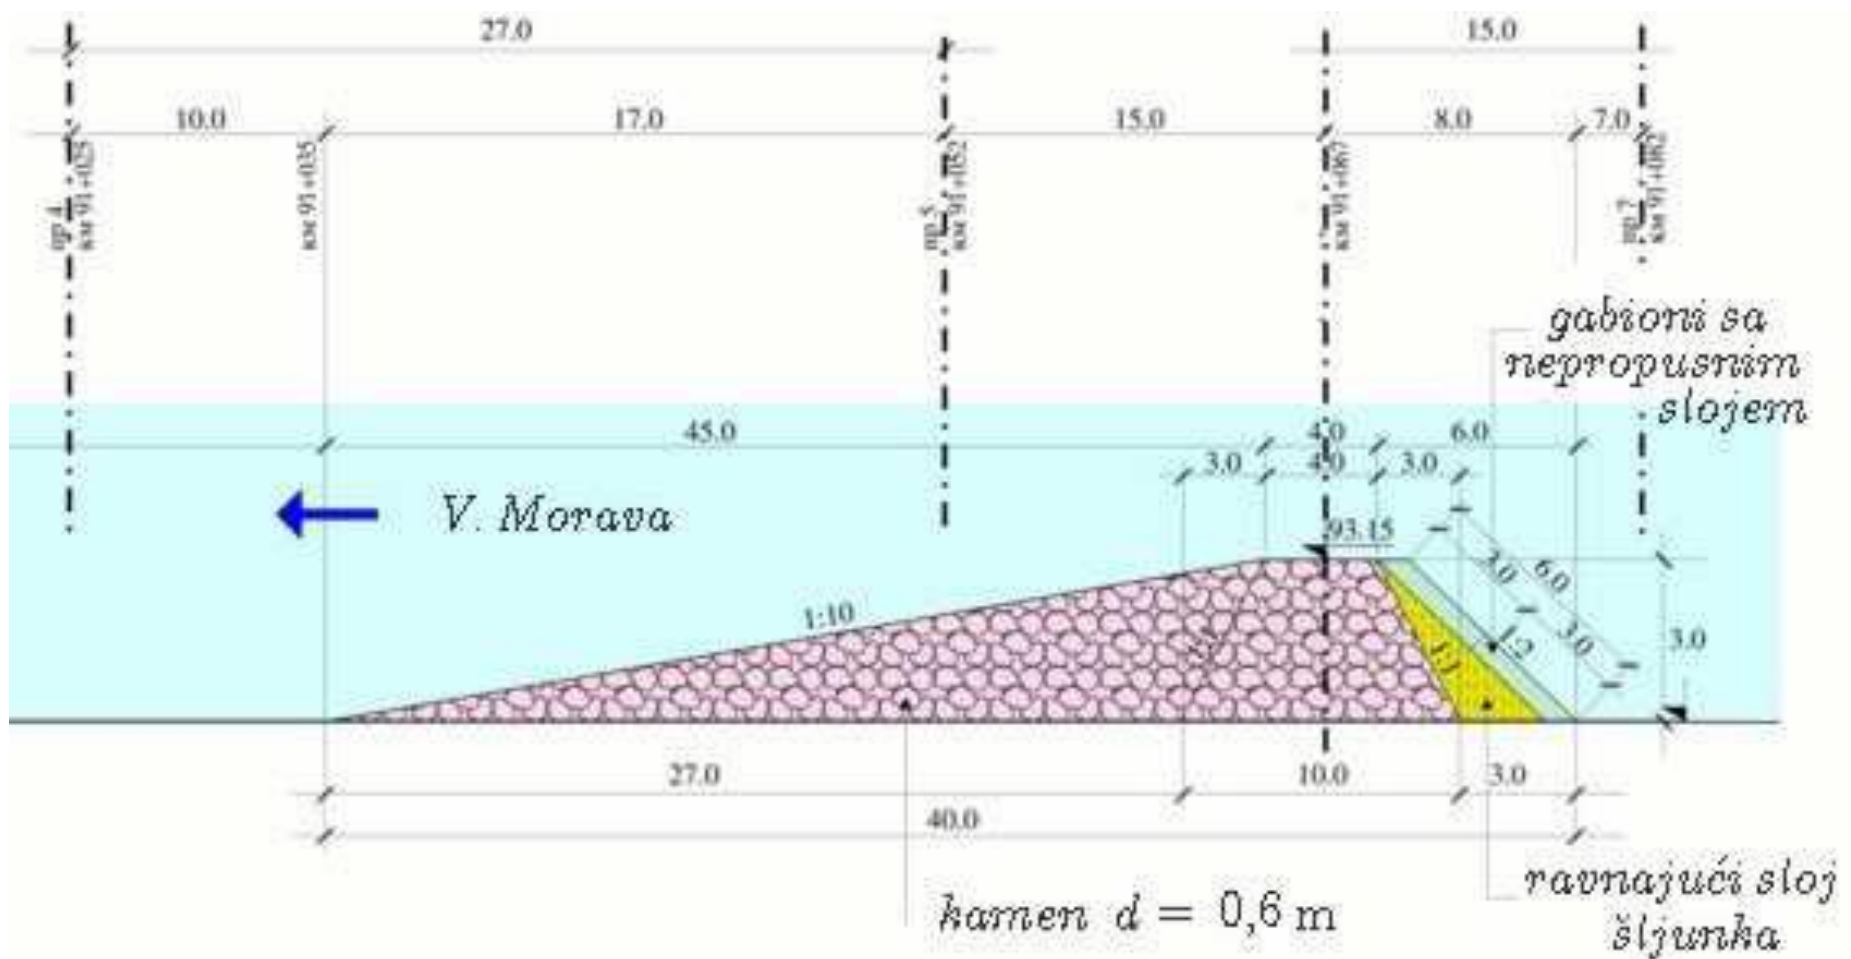
The designed sill under construction in allignment with the damaged old steel bridge at the bottom as the foundations.

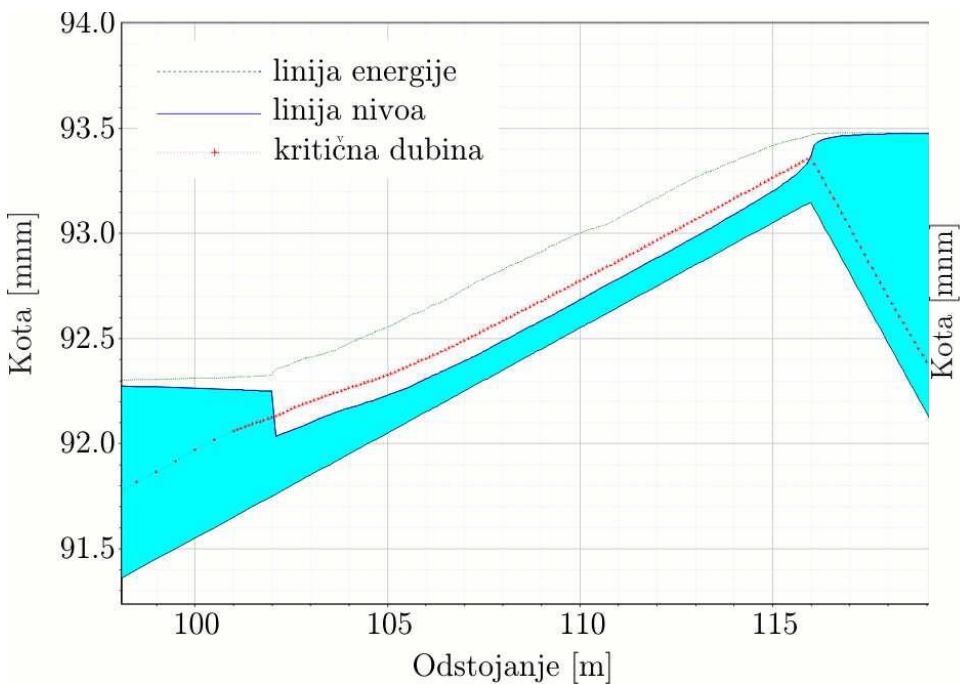
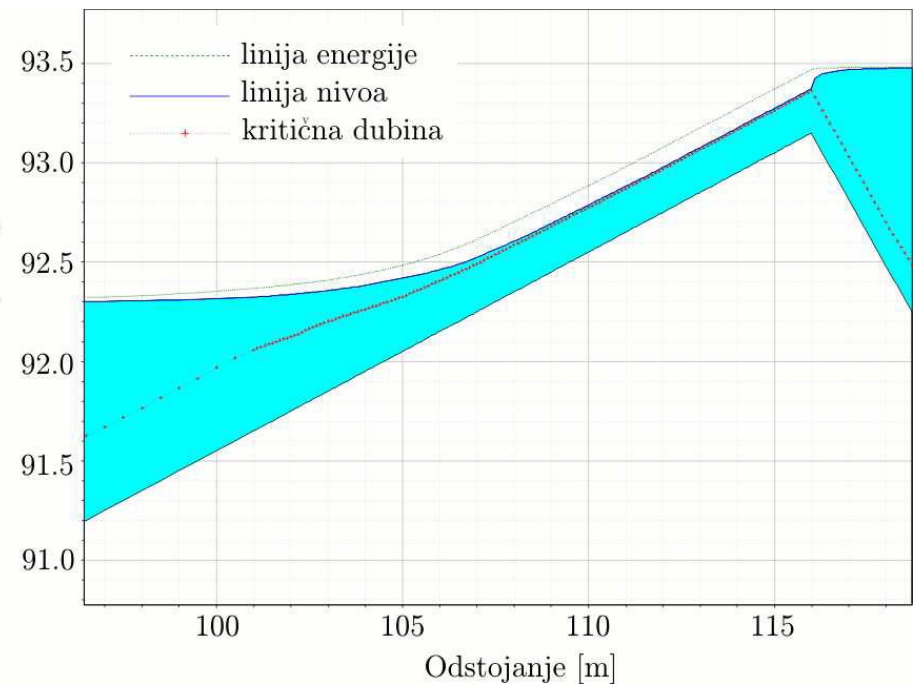
At left Fig.: water flow over sill modelled with only Manning roughness,

At right Fig.: water - air mixture flow with roughness defined according to Hartung & Scheuerlein method (1999)
